2010 Subaru Forester P0026 Fault - RH Oil Switching Solenoid Valve and RH Oil Pressure Switch Replacement

This guide is a fix for a P0026 Fault code, which causes a engine and stability control light to come on. Also causes flashing cruise control light.

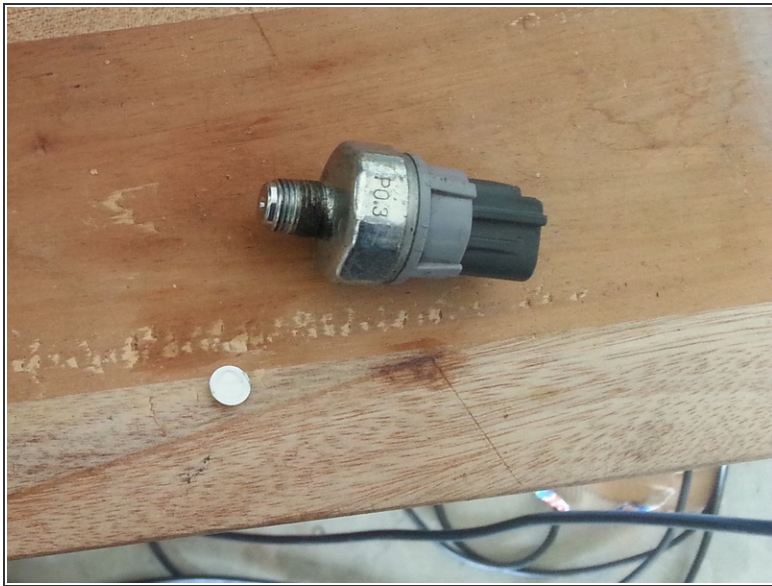
Step 5 — Remove Oil Pressure Switch

- Use a size 24 socket with extension bar to remove the Oil Pressure Switch.

- Apply liquid gasket to the Oil Pressure Switch threads. If you have a torque wrench, torque the switch to 17 Nm (12.5 ft-lb). The switch goes in tight, and it is easy to under torque it which I'm guessing would cause oil leaks.
- There is a small rubber gasket on the solenoid which needs to be oiled before Installed. Install the solenoid and tighten the size 10 bolt.

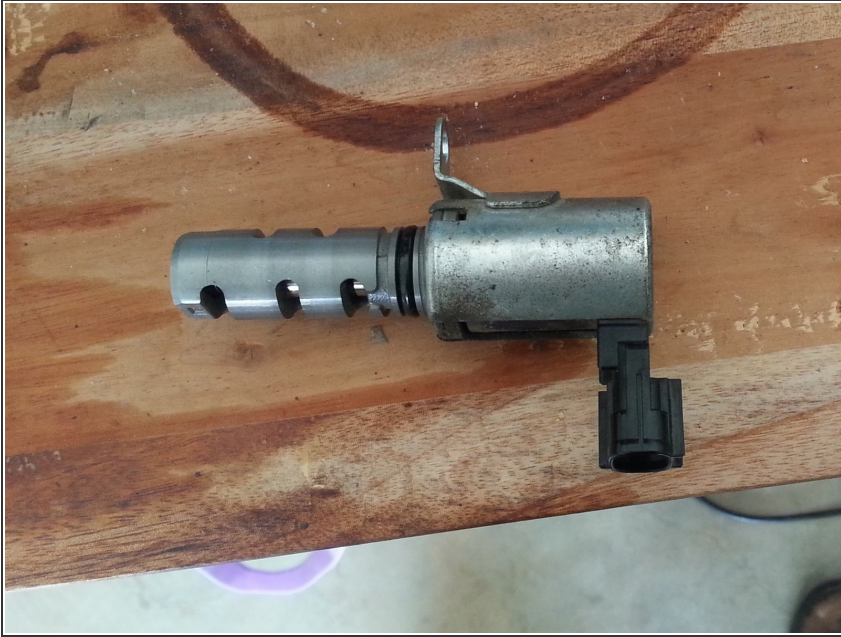
Step 6 — Remove Solenoid

- The bolt is located under the solenoid out of view. Use a size 10 socket to undo the bolt. Then remove the solenoid. You may need to use some force or multi grips to remove the solenoid.
